Advantage
Inspection

Roof Inspection

Sample Report

Date/Time: 6.15.2023 10:30 AM
Weather: 80 Degrees Sunny

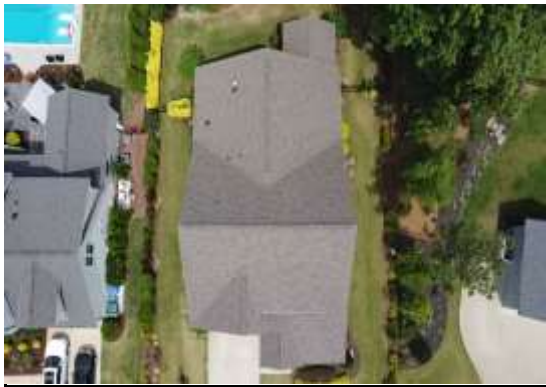
Photo 1

Overall Roof Photo

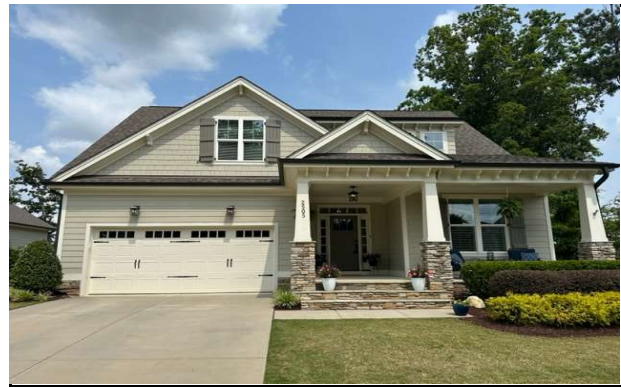
Photo 2

Elevation Photo

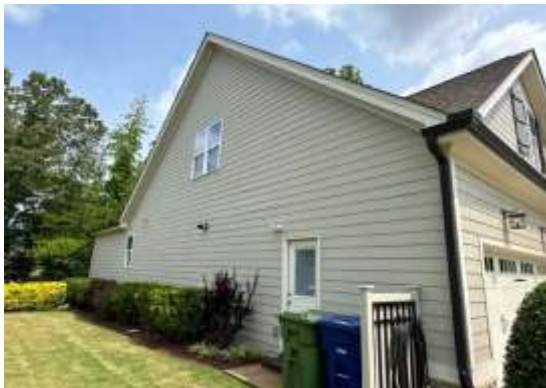
Photo 3

Elevation Photo

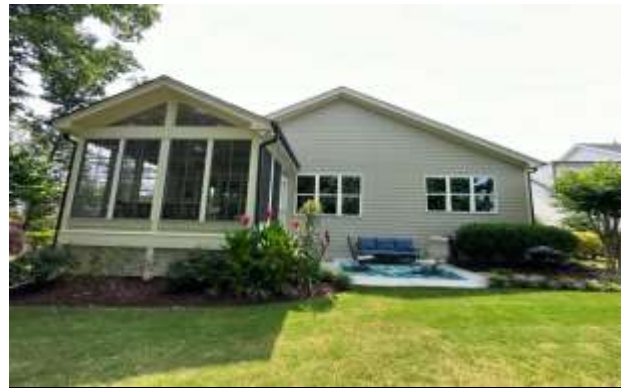
Photo 4

Elevation Photo

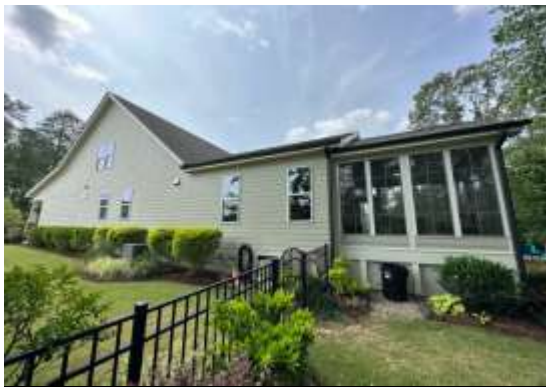
Photo 5

Elevation Photo

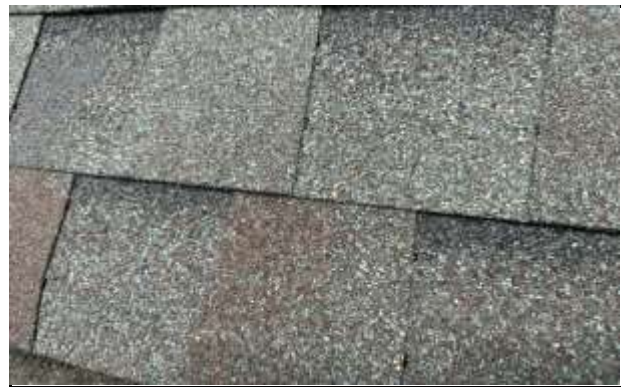
Photo 6

Shingle Condition - Granular attachment typical and consistent with age of roof.

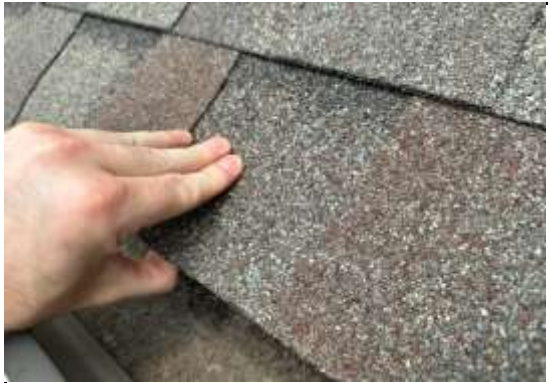
Photo 7

Shingle Condition - Granular attachment typical and consistent with age of roof.

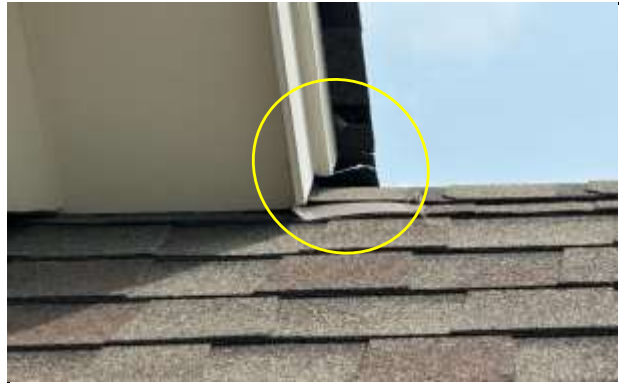
Photo 8

Shingle Condition - Shingle Damage/Missing Shingles/Granular Damage/Nail Pops/etc.

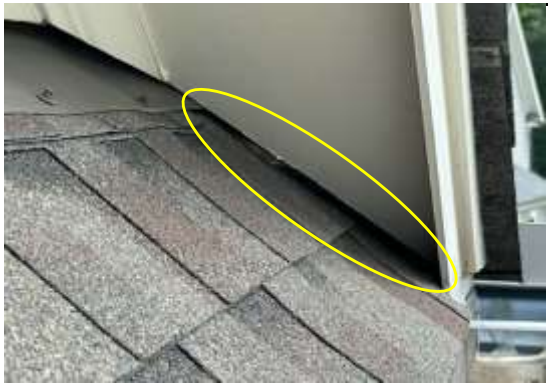
Photo 9

The gap between the soffit and roof shingles creates an opening into the attic for pests. Typically, flashing is installed in this area to seal off the attic.

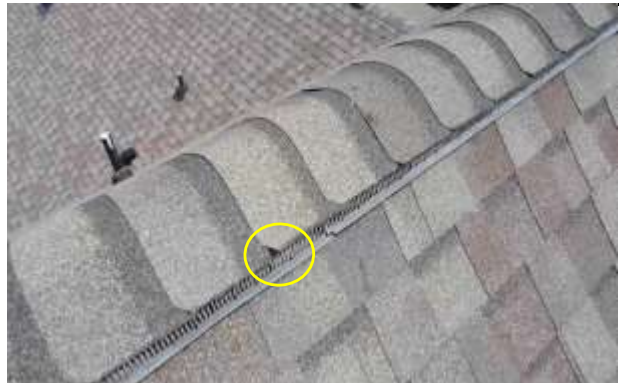
Photo 10

Shingle Condition - Shingle Damage/Missing Shingles/Granular Damage/Nail Pops/etc.

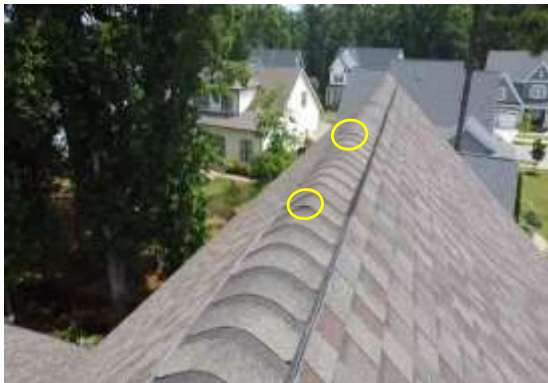
Photo 11

Shingle Condition - Minor shingle damage - missing shingle, lifting shingle, curling shingle, etc.

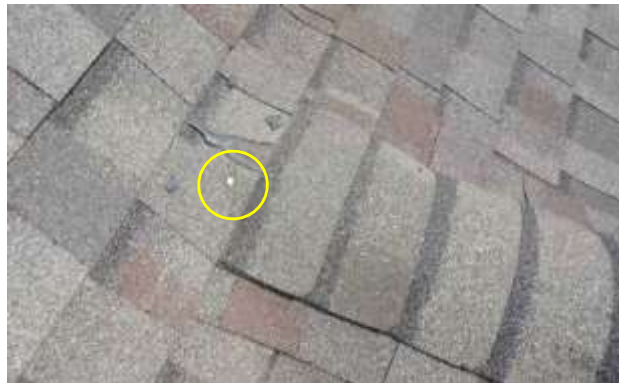
Photo 12

Shingle Condition - Sealant missing/deteriorated from nail heads.

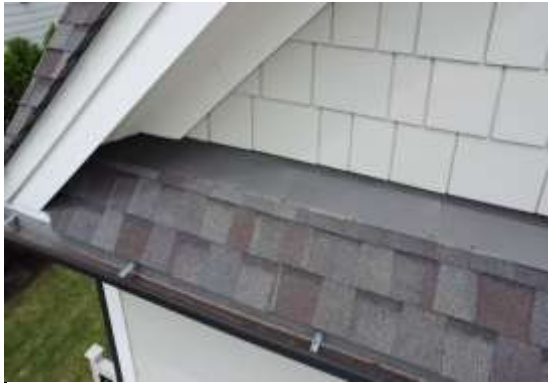
Photo 13

Flashing(s) at Overhang Returns - Flashings are properly installed and attachment is sealed properly

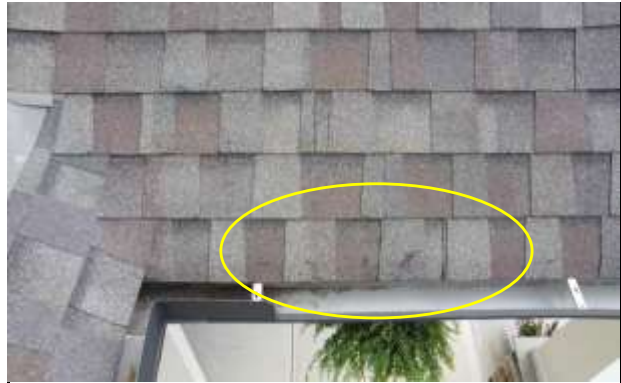
Photo 14

Shingle Condition - Shingle Damage/Missing Shingles/Granular Damage/Nail Pops/etc.

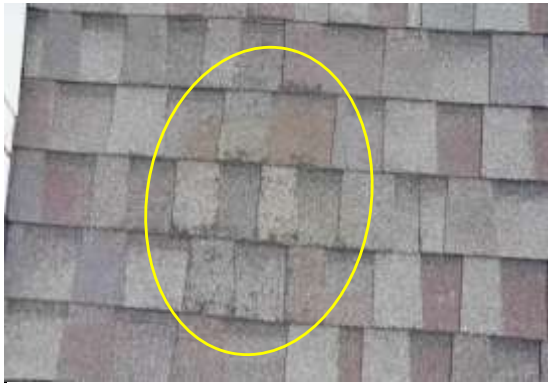
Photo 15

Shingle Condition - Shingle Damage/Missing Shingles/Granular Damage/Nail Pops/etc.

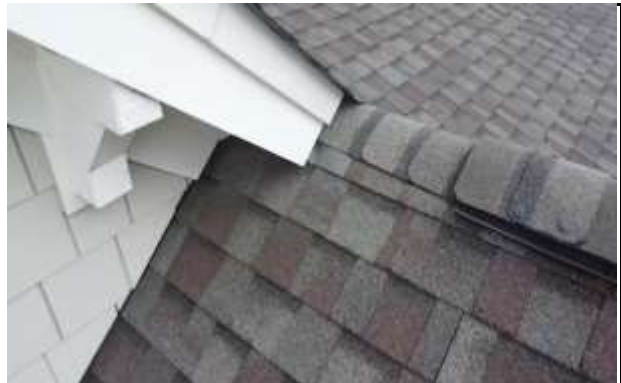
Photo 16

Flashing(s) at Overhang Returns - Flashings are properly installed and attachment is sealed properly

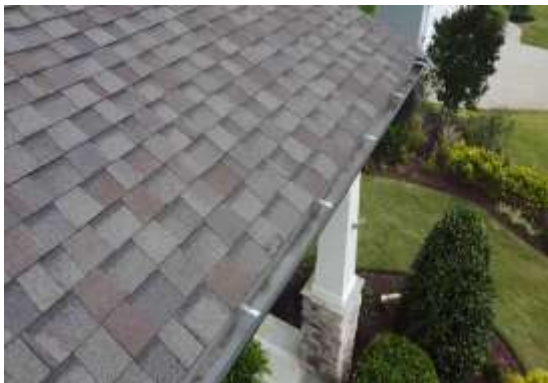
Photo 17

Gutters - Gutters are properly attached and function as intended/good shape

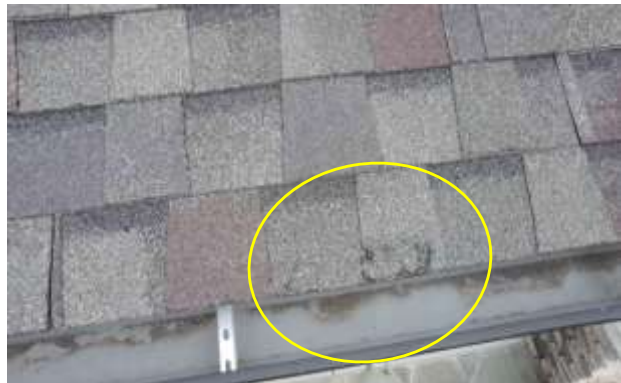
Photo 18

Shingle Condition - Shingle Damage/Missing Shingles/Granular Damage/Nail Pops/etc.

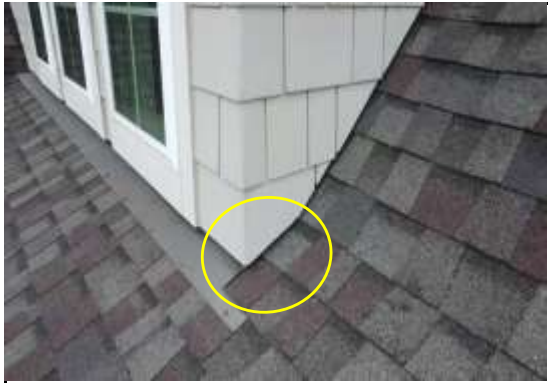
Photo 19
LOG

Flashing(s) Kickout - Kickout flashing(s) are missing where siding/shingles meet. Recommend professional contactor evaluate and install as necessary.

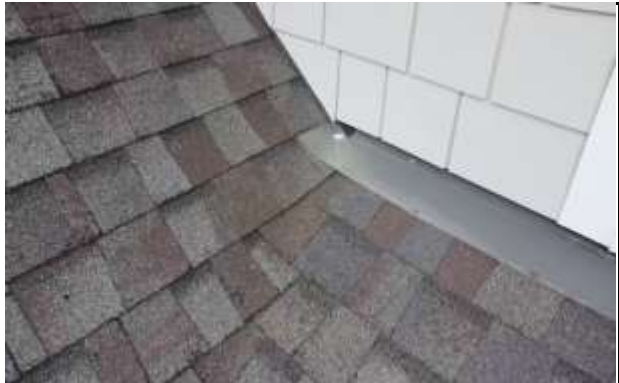
Photo 20
LOG

Flashing(s) at Overhang Returns - Flashings are properly installed and attachment is sealed properly

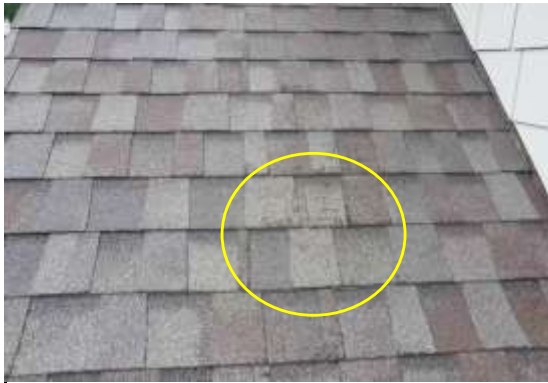
Photo 21
LOG

Shingle Condition - Shingle Damage/Missing Shingles/Granular Damage/Nail Pops/etc.

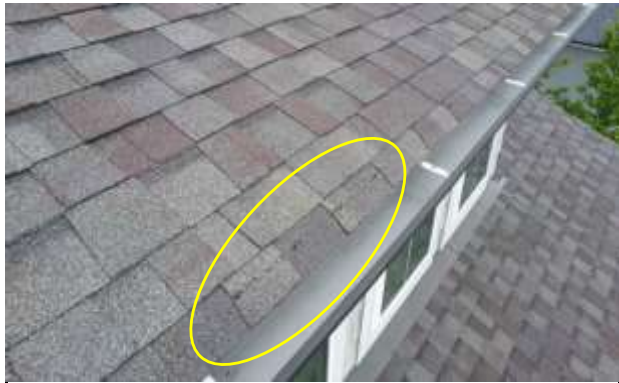
Photo 22
LOG

Shingle Condition - Shingle Damage/Missing Shingles/Granular Damage/Nail Pops/etc.

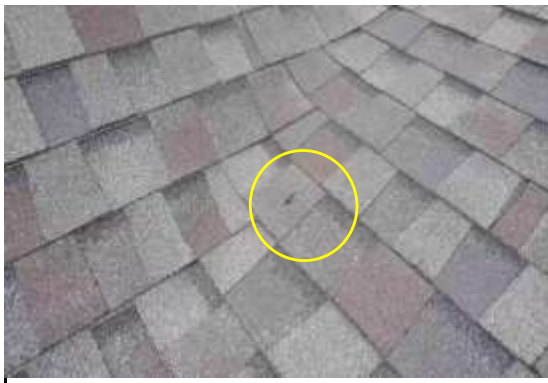
Photo 23
LOG

Shingle Condition - Observed nails/construction debris on the roof. Loose debris/nails can cause personal injury.

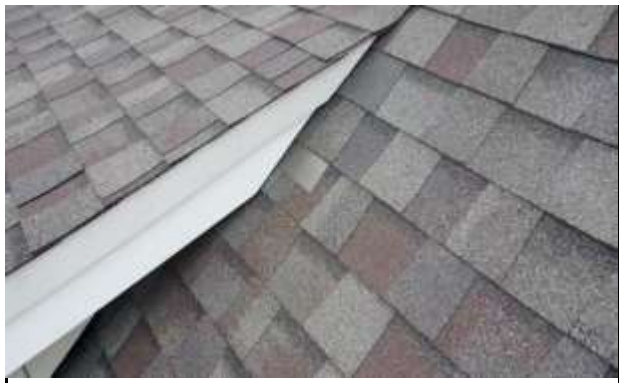
Photo 24
LOG

Flashing(s) at Shed Roof - Flashing are properly installed at shed roof component.

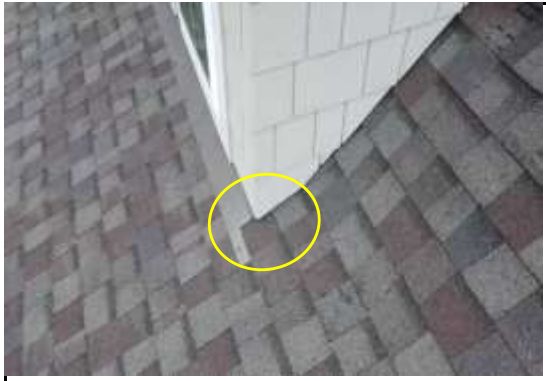
Photo 25
LOG

Flashing(s) Kickout - Kickout flashing(s) are missing where siding/shingles meet. Recommend professional contactor evaluate and install as necessary.

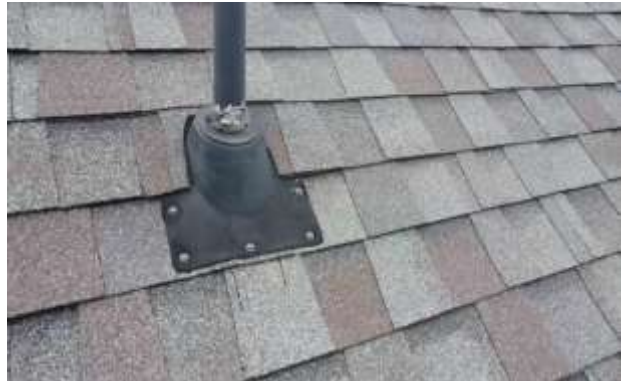
Photo 26
LOG

Plumbing Flashing - Plumbing flashings are in good shape. These flashing are recommended to be replaced every 8-10 years.

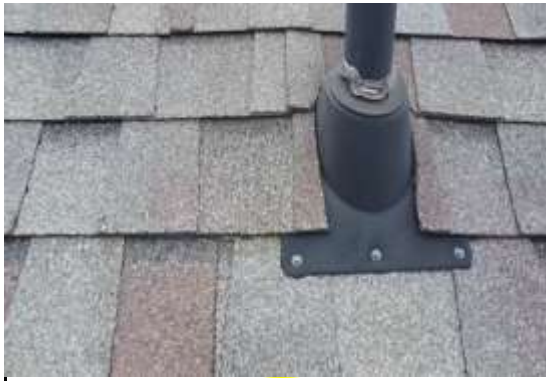
Photo 27
LOG

Plumbing Flashing - Plumbing flashings are in good shape. These flashing are recommended to be replaced every 8-10 years.

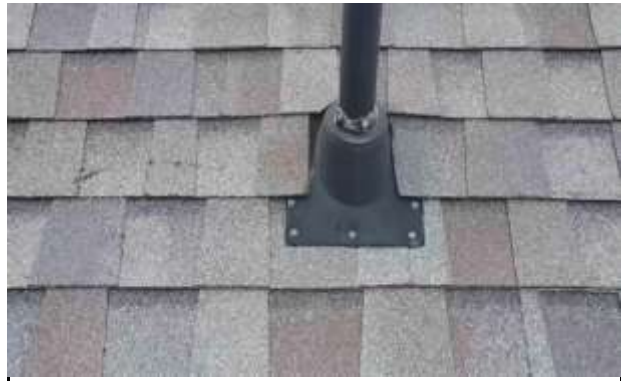
Photo 28
LOG

Plumbing Flashing - Plumbing flashings are in good shape. These flashing are recommended to be replaced every 8-10 years.

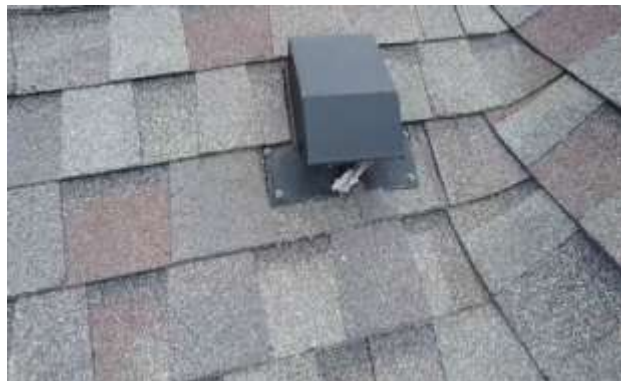
Photo 30
LOG

Mechanical Flashings - Mechanical flashings are in good shape. These flashings are recommended to be replaced every 8-10 years.

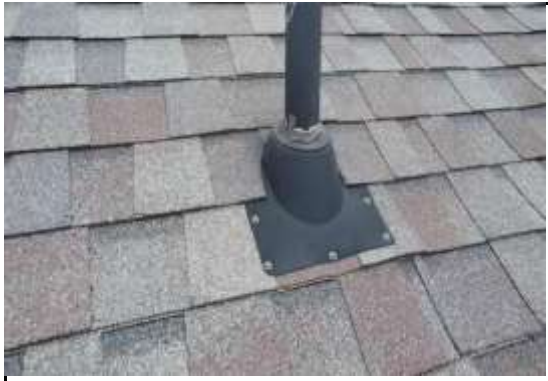
Photo 31

Plumbing Flashing - Plumbing flashings are in good shape. These flashings are recommended to be replaced every 8-10 years.

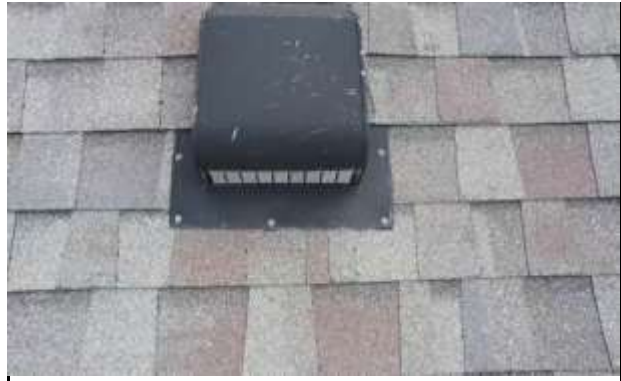
Photo 32

Mechanical Flashings - Mechanical flashings are in good shape. These flashings are recommended to be replaced every 8-10 years.

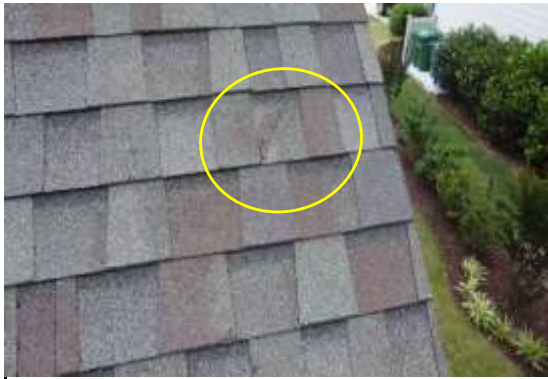
Photo 33

Shingle Condition - Shingle Damage/Missing Shingles/Granular Damage/Nail Pops/etc.

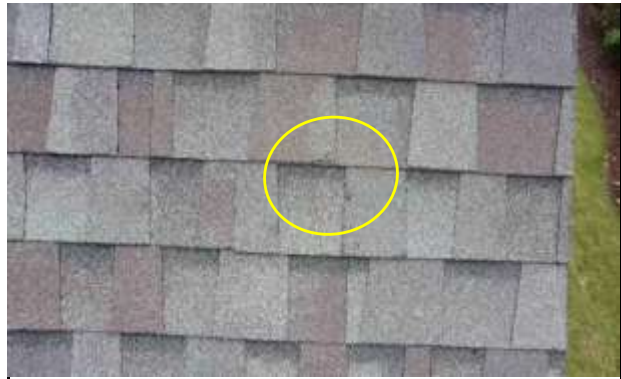
Photo 34

Shingle Condition - Shingle Damage/Missing Shingles/Granular Damage/Nail Pops/etc.

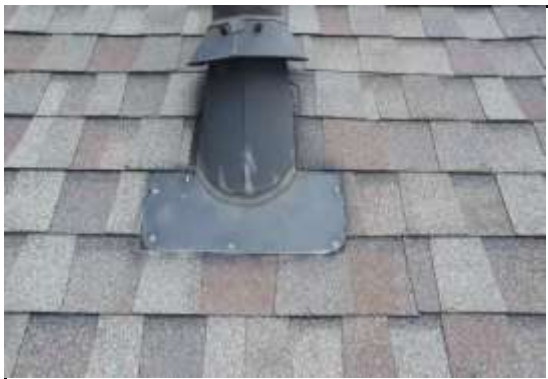
Photo 35

Mechanical Flashings - Mechanical flashings are in good shape. These flashings are recommended to be replaced every 8-10 years.

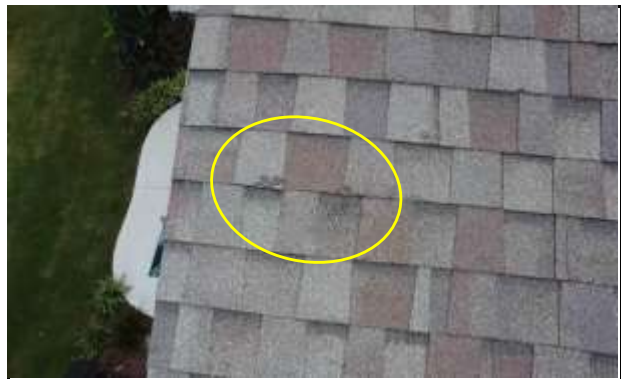
Photo 36

Shingle Condition - Shingle Damage/Missing Shingles/Granular Damage/Nail Pops/etc.

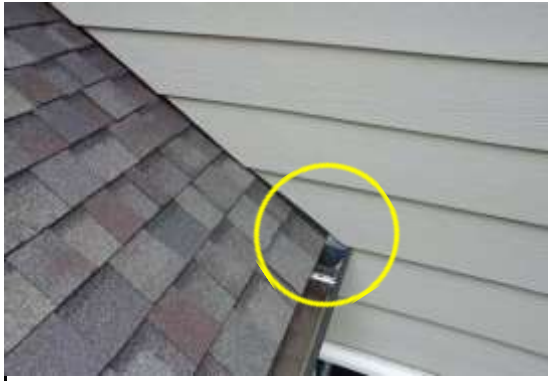
Photo 37
LOG

Flashing(s) Kickout - Kickout flashing(s) are missing where siding/shingles meet. Recommend professional contactor evaluate and install as necessary.

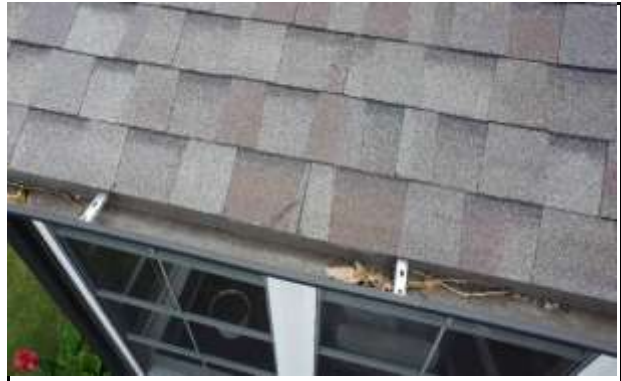
Photo 38
LOG

Gutters - Gutters are properly attached and function as intended/good shape

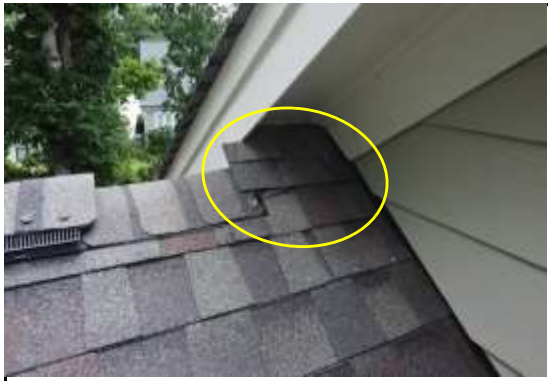
Photo 39
LOG

Flashing(s) at Shed Roof - Flashing are not properly installed at shed roof component.

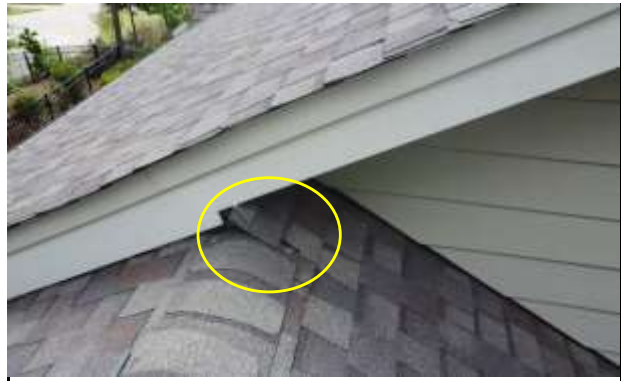
Photo 40
LOG

Flashing(s) at Shed Roof - Flashing are not properly installed at shed roof component.

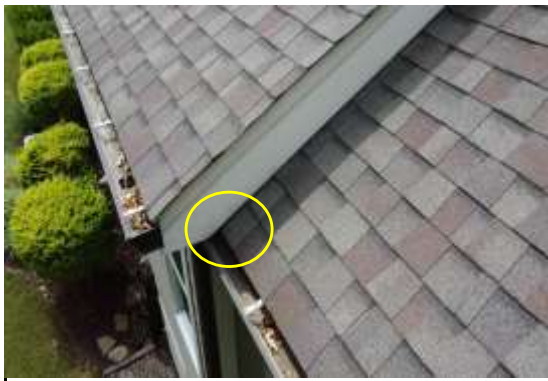
Photo 41
LOG

Flashing(s) Kickout - Kickout flashing(s) are missing where siding/shingles meet. Recommend professional contactor evaluate and install as necessary.

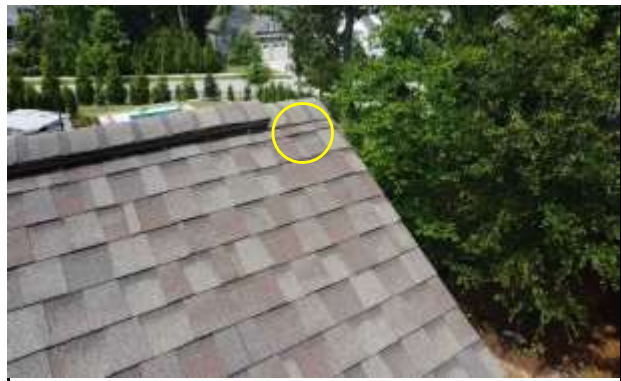
Photo 42
LOG

Shingle Condition - Shingle Damage/Missing Shingles/Granular Damage/Nail Pops/etc.

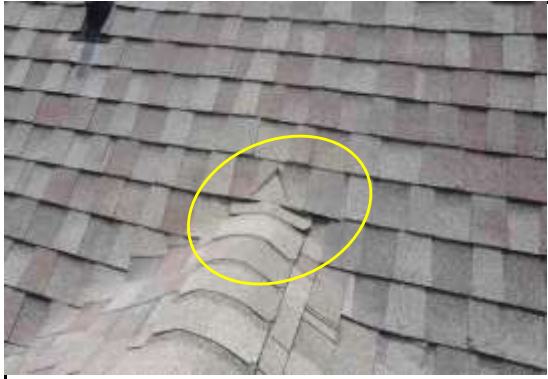
Photo 43

Flashing above ridge is missing fasteners.

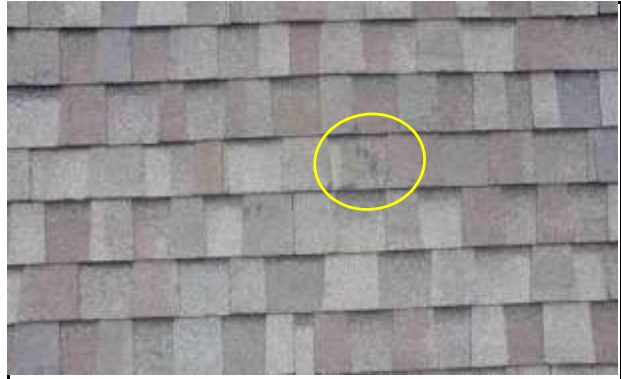
Photo 44

Shingle Condition - Shingle Damage/Missing Shingles/Granular Damage/Nail Pops/etc.
