Inspection Report

Report - Property/Home
Inspection

06.26.24

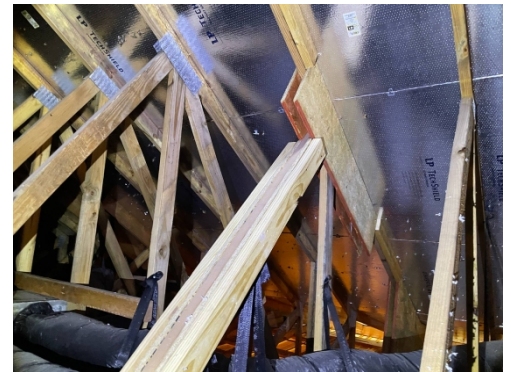
1. Needs Further Evaluation: Roof Framing - Truss Damage Repair Present - Observed a broken web member on an attic roof truss above the living room area which has been provided with an on site repair. It is not uncommon to have some areas of damage on a truss due to packaging and shipping from the manufacture and installation at the time of the home's construction. Even though the repair is mostly consistent with similar repairs specified by professional engineers, only a registered engineer can certify structural integrity. It may be that the municipal building department has a letter on file from the truss engineer that validates that the repair modification was evaluated and repaired per professional specifications. If this verification cannot be provided, further evaluation and repairs specified by a structural engineer and contractor are recommended in order to ensure that the intended structural integrity of the truss is provided.

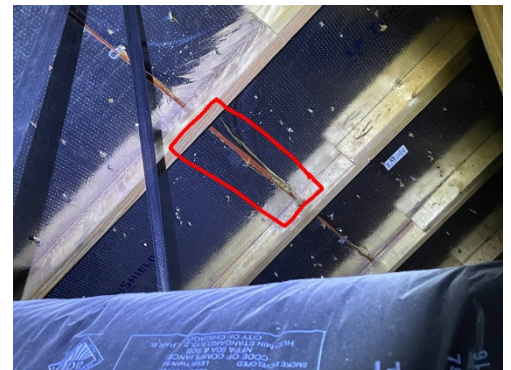
2. Needs Repair: Roof Decking Missing Clip - An area above the living room/dining area was noted as not having a roof decking clip properly installed between the roof trusses at the breaks in the roof decking. (See Photo) Clips provide support at the butt joints in the roof sheathing in trussed roof systems due to the larger spacing allowed between the individual trusses themselves. Concerns for buckling of the sheathing and/or poor supporting of the sheathing when walked on is present due to the clips not being properly installed. It is recommended that a professional contractor familiar with trussed roof construction evaluate all accessible areas of the roof sheathing providing supplemental support boards under any butt joints that are not provided with proper installation of the decking clips.

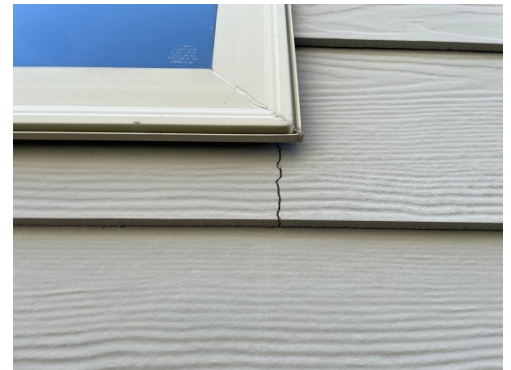
3. Needs Repair: Exterior Wall Cladding - Damaged Siding - Observed some damaged sections of fiber cement siding on the exterior of the home. Openings in the wall cladding can allow moisture to get behind the wall cladding where damage can occur. Have a professional siding contractor evaluate the home's entire siding application/installation and make any necessary repairs to prevent possible moisture intrusion and to ensure long term serviceability of the wall cladding.

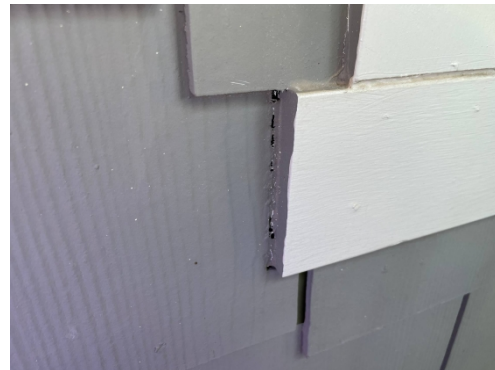
4. Needs Repair: Exterior Trim - Deteriorated Sealant -

Unions of doors/window frames/exterior trim to the exterior wall cladding have areas of sealant adhesion failure present. Caulked joints that have cracked and/or separated need to be sealed in order to prevent any possibility of water intruding into the walls where damage can occur. Have a professional contractor properly prepare/reseal all areas where joints have been compromised.

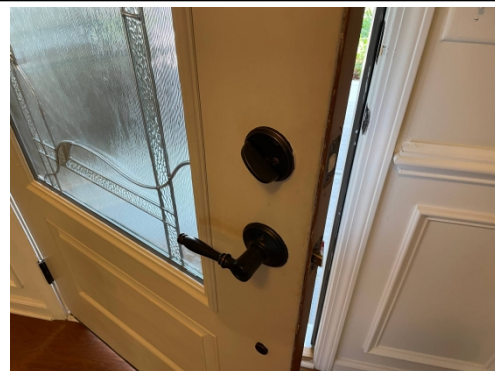
5. Needs Repair: Front Entry Door - Not Sealing, Latching and Locking Properly -

The front door is not making a good seal on the weather strip insulation provided. The door is not latching properly and the deadbolt is difficult to engage in the door frame. This can allow conditioned air to leak from the home, and provide an access point for pests into the home. This will prevent the door from being properly secured. Have a professional contractor evaluate the door installation and make the necessary repairs to allow the door to seal properly when closed.

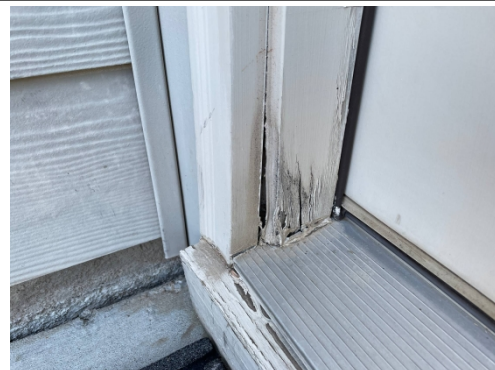
6. Needs Repair: Rear Door - Moisture Damage to Rear Door Trim -

The rear exterior door lower side wood jambs have wood deterioration present. Suggest adding a rain diverter along the roof edge to reduce water from running off the roof at the door trim area. Long term exposure to moisture can result in damage to the wood components of this door system and repairs/replacement are necessary. Have a professional contractor make all necessary repairs for long term serviceability.

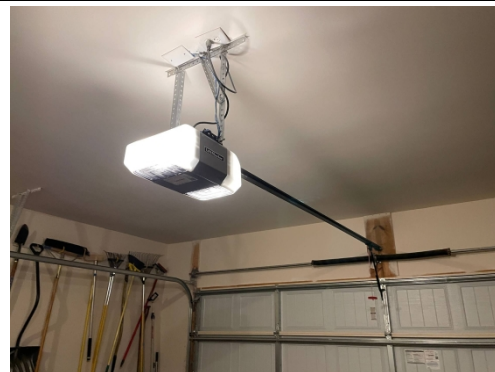
7. Needs Repair: Garage - Garage Door Opener Down Force Adjustment Needed -

The garage door did not reverse motion when a small amount of resistance (three fingers alone used to stop downward motion) were applied to the door while closing. Improperly set door openers can result in damage to the door/personal property, or personal injury. Have a professional garage door installation contractor adjust the downforce on the automatic garage door opener auto-reverse function so that less resistance is required in order to reverse downward door motion.

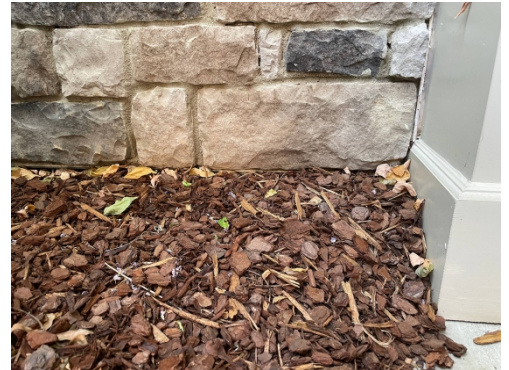
8. Needs Repair: Mulch/Ground Cover - Siding/Trim Buried -

Observed piles of mulch/ground cover that are at or above the lower edge of the siding/trim on the home. Siding or trim extending below the grade/grade cover can allow for unseen moisture damage to occur, as well as, provide an easy access point for termites to get to the wood framed structure. Recommend that a professional contractor make any necessary repairs to expose a minimum of 6" of foundation wall below the siding/trim to prevent damage and allow for regular evaluation.

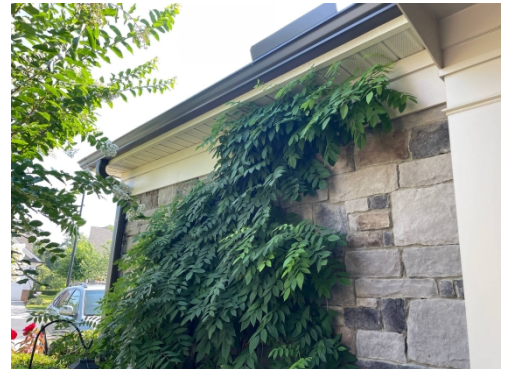
9. Needs Repair: Shrub Limbs/Vines - Limbs/Vines In Contact With The House -

Observed vines/shrub limbs that are in contact with the home. Branches in contact with the house can cause damage to the shingled roof covering and water shedding off the trees can divert water toward the house. The canopy under large trees will hold higher moisture levels in them that will over time cause wood to deteriorate. Maintain large vegetation away from the house in order to prevent damage to the house and reduce higher moisture levels that can cause rot on wood surfaces.

>>> Note: Limbs over the fireplace chimney can cause poor drafting/back drafting in the fireplace.

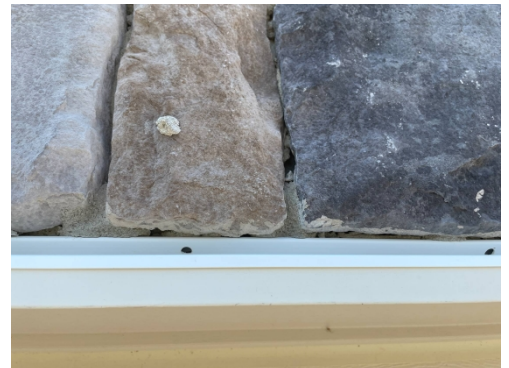
10. Needs Repair: Exterior Wall Cladding - Openings in Stone Veneer - Observed some openings in the stone veneer on the front elevation of the home. (See Photo) A veneer does not support the weight of any structure, but does support the weight of the stone. Openings in the mortar joints in the veneer can cause stones to fall from the wall as a result. Additionally, openings in these joints between the stone can allow water to intrude into openings and during extremely cold weather, freezing conditions will expand water and cause stone to crack or dislodge. Have a professional masonry contractor seal any open joints in the veneer exterior of the home.

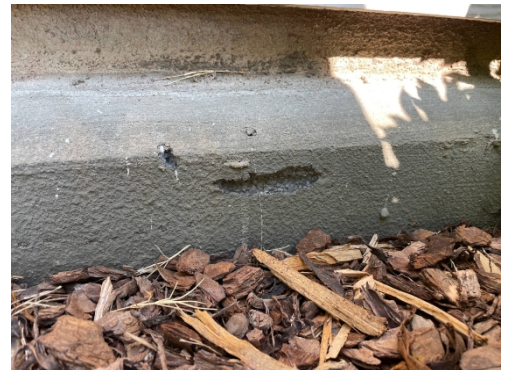
11. Needs Repair: Slab Foundation - Insulation Damaged -

This house has a concrete slab foundation. Some areas of the applied insulation on the left elevation have been damaged, likely due to assumed landscape equipment. (See Photo) This will reduce the insulation rating provided to the slab. Have a professional contractor make the necessary repairs to these areas to restore the insulation.

>>> Note: Caution is advised when providing exterior maintenance in the yard in order to prevent any further damage from occurring.

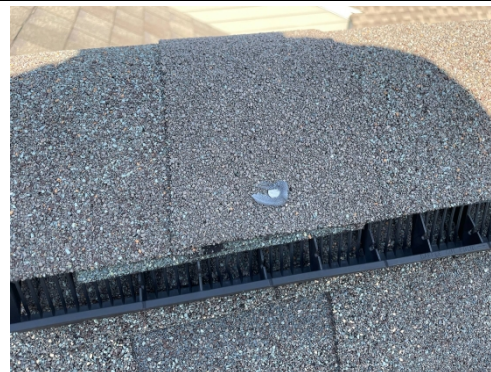
12. Needs Repair: Roof Covering - Unsealed Nail Heads -

Observed unsealed nail heads in the shingles/flashings around the roof. (See Photo) Unsealed nails heads can allow moisture to penetrate around the nails shaft which can result in moisture damage to the roof decking. Have a professional roofing contractor evaluate the entire roof area and properly seal all exposed nail heads.

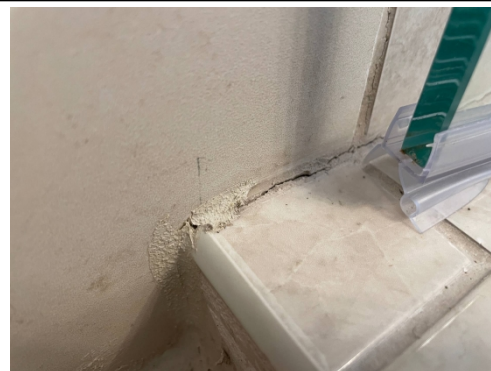
13. Needs Repair: Front Right Bedroom Bathroom - Shower Tile/Grout - The shower tile has evidence of cracking/separation present between the tiles/grout/sealant. (See Photo) Water that is able to intrude under the tile and can, over time, deteriorate the wall or floor structure under/behind the tile. Recommend having a professional tile installation contractor provide further evaluation and at a minimum, properly repair the deteriorated grout joints, so that the possibility of water penetration is prevented.

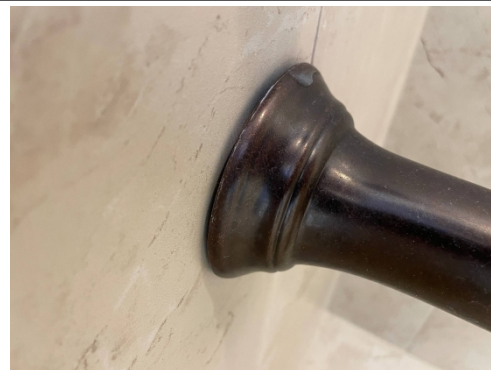
14. Needs Repair: Front Right Bedroom Bathroom - Shower Handle & Spout Not Sealed/Loose - The shower handle & spout needs to be sealed/caulked to the wall of the shower. (See Photo) Water is able to get behind the shower wall when turned on. Loose fixtures can damage plumbing connections over time. Have a professional plumbing contractor evaluate all of the bathroom fixtures in the home and properly seal any openings.

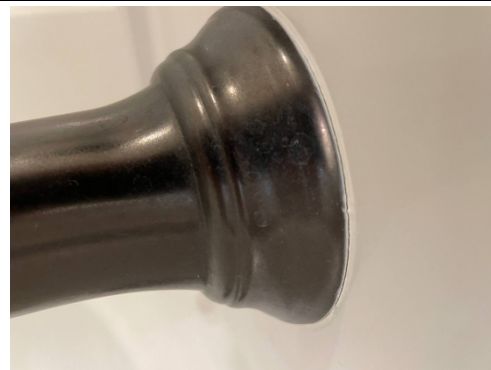
15. Needs Repair: Hallway Bathroom - Tub Spout Not Sealed -

The tub spout and water valves need to be sealed/caulked to the wall of the tub/shower in the hall bathroom. (See Photo) Water is able to get behind the shower wall when turned on. Have a professional plumbing contractor evaluate all of the bathroom fixtures in the home and properly seal any openings.

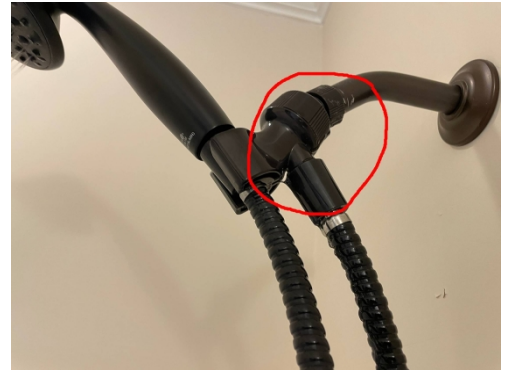
16. Needs Repair: Hallway Bathroom - Shower Head Leaks -
Observed the shower head in the hall bathroom to leak at the various connections when in use. (See Photo) Water leaking at these locations can reduce water pressure for the shower. Recommend that a professional plumbing contractor make the necessary repairs to prevent further leaking while the shower is in use.

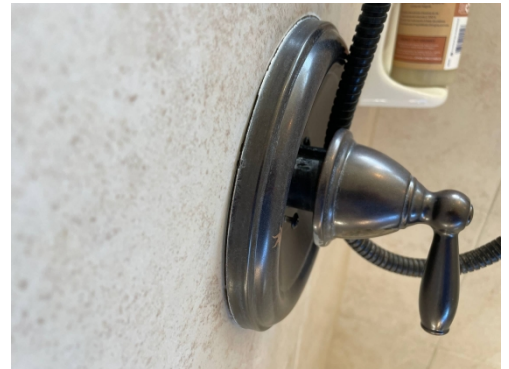
17. Needs Repair: Primary Bathroom - Shower Handle Not Sealed & Loose -
The shower handle needs to be sealed/caulked and properly secured to the wall of the shower. (See Photo) Water is able to get behind the shower wall when turned on. Loose fixtures can damage plumbing connections over time. Have a professional plumbing contractor evaluate all of the bathroom fixtures in the home and properly seal any openings.

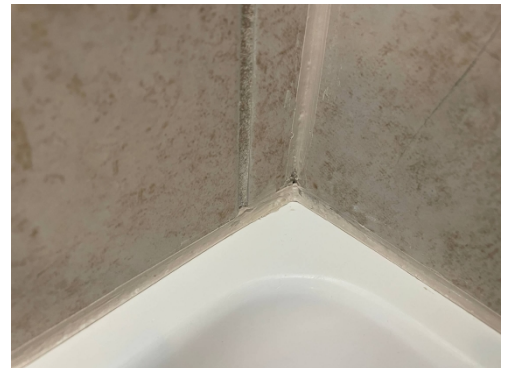
18. Needs Repair: Primary Bathroom - Shower Sealant Maintenance Needed -
The shower in the primary bathroom needs preventative maintenance (sealant) applied at the union of the wall and floor. (See Photo) Typically observed small cracks in the grout or sealant in this area should be maintained or sealed by using an appropriate sealant. Gaps at these areas can allow water to intrude under the shower and cause damage over time. Have a professional contractor fully evaluate the shower and properly seal any gaps/cracks.

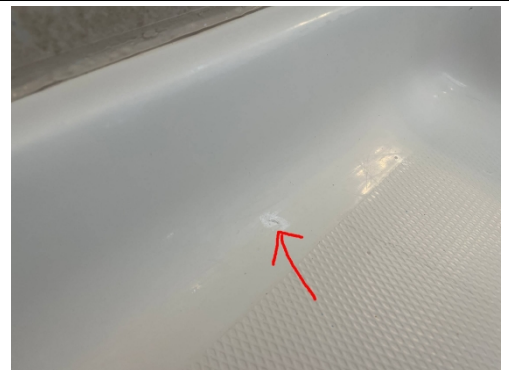
19. Needs Further Evaluation/Repair: Primary Bathroom - Damaged Shower Surround -
Observed areas of damage in the primary bathroom shower floor with patch work observed. (See Photo) These areas of damage can allow moisture to leak under the shower where damage can occur. Recommend that a professional contractor make the necessary repairs to prevent any possibility of leaking.

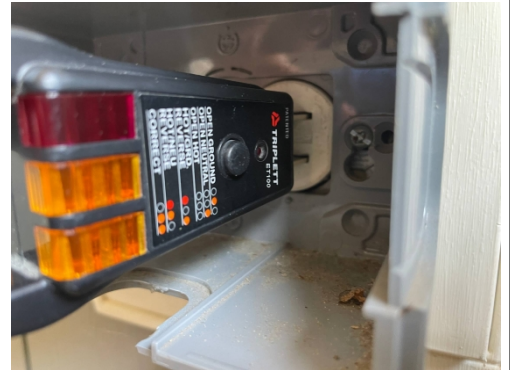
20. Needs Repair: Outlets - Outlet - The front porch outlet near the door had one of the receptacles obstructed. (See photo) The outlet was not able to be fully tested. This limits/prevents use of the outlet. Have a professional electrical contractor remove the obstruction from the outlet so that proper operation can be provided.

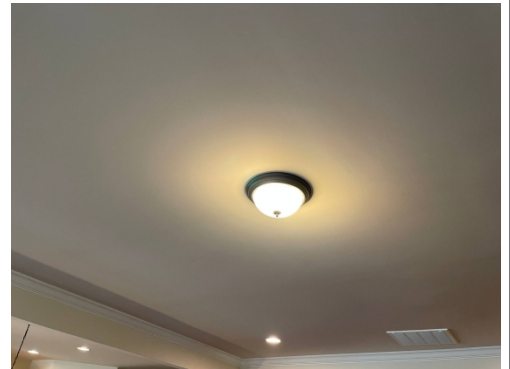
21. Needs Repair: Interior Lighting - Wrong Three-way Switch Wiring Configuration - The 3-way switch configuration serving the living room middle ceiling light does not work properly. One switch must always be in the on position for the other switch to work. Have a professional electrical contractor evaluate the circuit and make any necessary repairs in order to restore proper/independent operation at all switch locations.

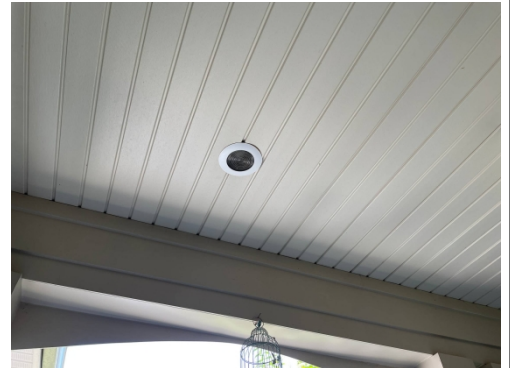
22. Needs Repair: Exterior Lighting - Exterior Lights Not Operating - The front porch light fixture did not turn on at the time of the inspection. Replace missing/burned out bulb and/or have a professional electrical contractor make any additional repairs necessary in order to assure that the electrical circuit serving the fixture is working properly.

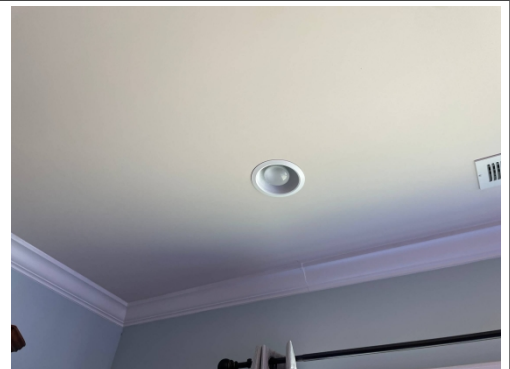
23. Needs Repair: Interior Lighting - Interior Lights Not Operating - The rear sitting room light fixture did not turn on at the time of the inspection. Replace missing/burned out bulb and/or have a professional electrical contractor make any additional repairs necessary in order to assure that the electrical circuit serving this fixture is working properly.

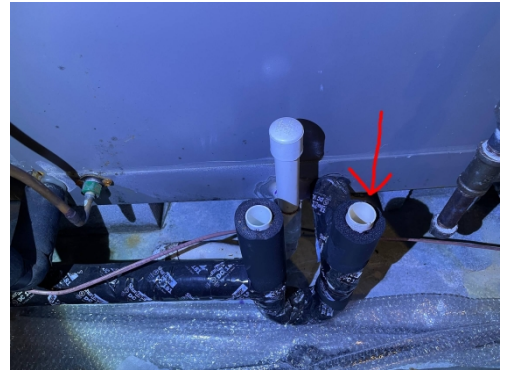
24. Needs Repair: HVAC Unit - Air Loss Through Condensate Line -

The HVAC unit condensate line vent/cleanout - located between the line trap and the connection to the air handler - is venting a considerable amount of conditioned air to the area. An open condensate drain line will reduce the efficiency of the system, as well as cause negative pressures in the closed air system. This open cleanout or vent should either be covered (An easily removable cap or plug should be installed) or relocated to the downward drain side of the line trap so that the closed air system is not venting air from the system and is not causing negative pressure inside. Recommend having a professional HVAC contractor evaluate the HVAC unit installation and make any necessary repairs for long term serviceability.

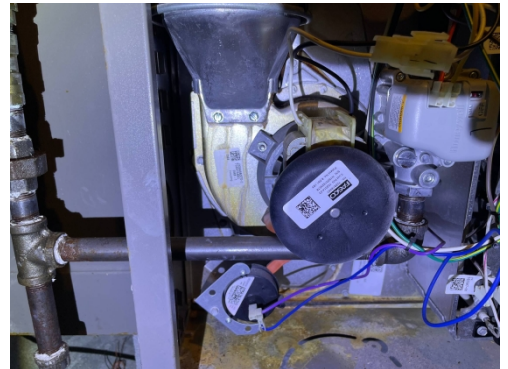
25. Needs Repair: HVAC Unit - Rust on Interior of Furnace -

Observed rust around the fan housing, bottom of the furnace & burner ports in the HVAC unit. (See Photo) Rust may result in damage to the burners in the HVAC unit which can lead to the incomplete burning of gasses which can result in higher carbon monoxide levels and increased utility costs. Have a professional HVAC contractor evaluate the system and make any necessary repairs for normal safe operation to occur.

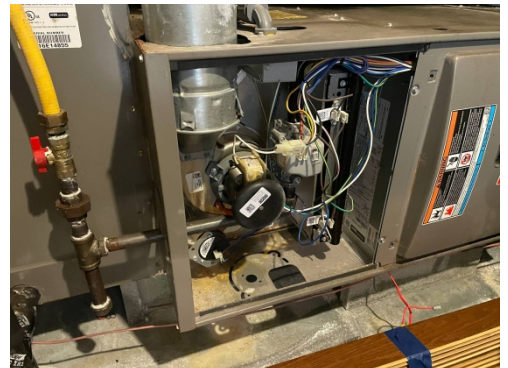
26. Needs Repair: Attic HVAC Unit - Noisy Fan Operation -

When operating the HVAC unit there was a slight rattling noise observed in the furnace near the fan housing area. Noisy operation can result in damage to the equipment. Recommend that a professional HVAC contractor evaluate the system and make any necessary repairs to ensure proper operation and long term serviceability.

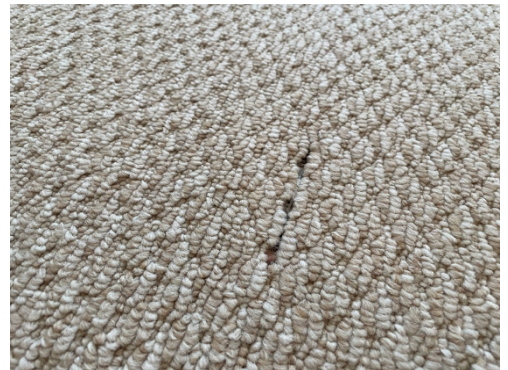
27. Needs Repair: Flooring - Loosely/Torn Carpet -

A section of the carpet in the 2nd floor loft is torn/separating and can become a tripping hazard. Loose carpet can become damaged further over time and seams can lift up. Have a professional contractor evaluate the carpet throughout the home and make the necessary repairs for safe passage.

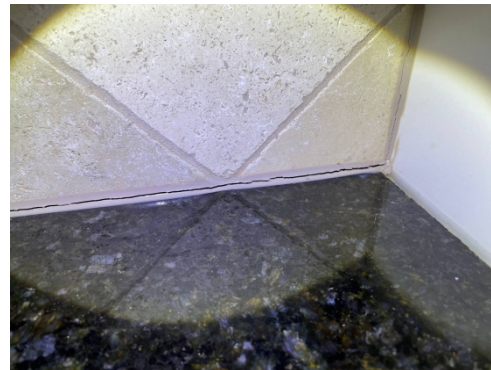
28. Needs Repair: Counters and Cabinets - Sealant Missing/Cracked -

Observed deteriorated sealant at the kitchen countertop and backsplash connection. The primary bathroom counter sealant has gaps observed. Moisture/water can penetrate this gap and damage the wall over time. Recommend that this countertop be sealed by a professional contractor to prevent possible moisture damage.

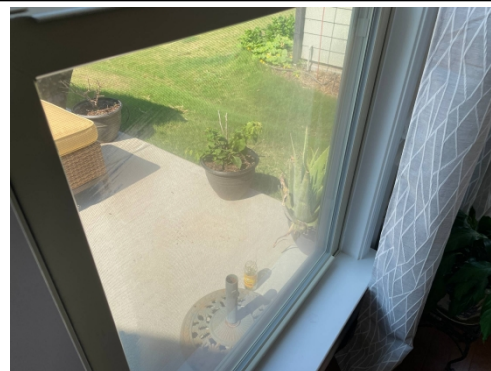
29. Needs Repair: Windows - Window Glass Unit Seal Failure -

Glass unit window insulation seals were observed to be compromised in a few locations throughout the home. - [Dining area bottom sash(1) & primary bedroom top sash(1)] Compromised glass seals may not necessarily be limited to just the glass units noted. Signs of compromised glass seals can be masked by weather conditions, lighting, and cleanliness of glass at the time of the inspection. Have a professional window pane replacement company evaluate all of the glass units in the home and make the necessary repairs/replacement to restore the insulation integrity of any units determined to have bad seals.

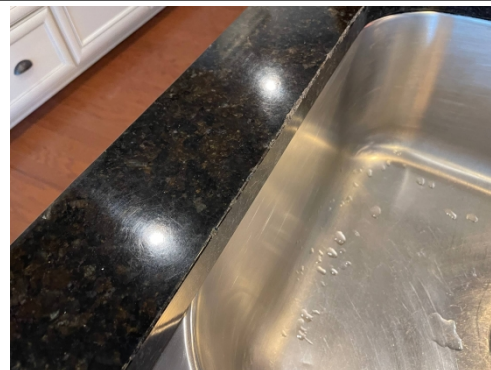
30. Needs Repair: Counters and Cabinets - Damaged Countertop -

Observed a damaged section of countertop in the kitchen at the sink. (See Photo) The chipped area is sharp and could result in personal injury. Have a professional contractor evaluate the counter and make the necessary repairs for safe use.

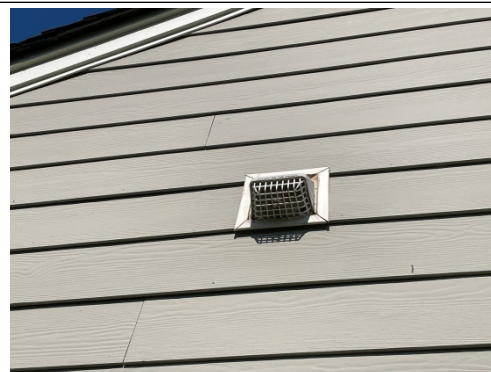
31. Needs Repair: Bathroom Exhaust Vent - Bathroom Exhaust Vent Flap Not Closing Fully - The exhaust vent flap serving the primary bathroom exhaust duct has the baffle stuck in a partially open position on the left elevation. (See Photo). The open flap can allow access of outside air into the house and/or birds have been known to nest in the opening. Have a professional contractor make the necessary repairs/replacement to this duct end cap so that proper operation is provided.

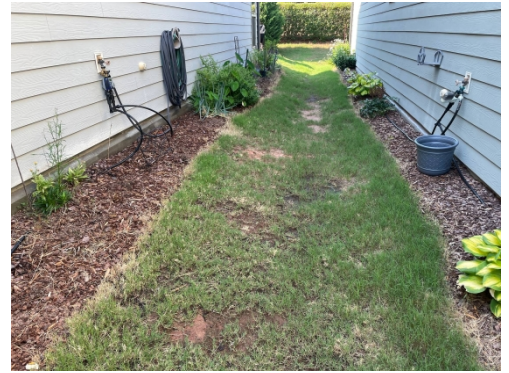
32. Observation/Information: Grading Swale Possibly Holding Water - Grading is diverting water away from foundation but the long narrow run of sculpted grade swales between the neighboring homes has low areas that can hold small amounts of water for short periods of time after long durations of rainfall. Standing/stagnant water is a health concern because it can promote insect and bacterial growth. These areas will have to be monitored over the first year in the house in order to ensure that standing water is not being retained for extended periods of time.

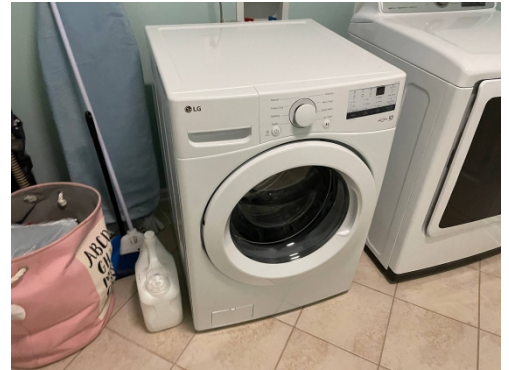
34. Suggestion: Missing Washing Machine Drain Pan - There is no washing machine emergency drain pan installed for the washing machine. This can result in water damage to the floor/ceiling below this area should the washing machine or lines leak. Suggest that a drain pan be added so that protection against water damage from leaking appliance can be provided.

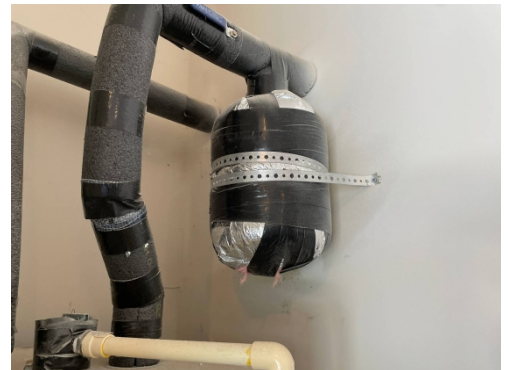
35. Limited Evaluation: Thermal Expansion Tank Wrapped - An insulation blanket prevented full inspection of the thermal expansion tank. A thermal expansion tank is a plumbing device associated with a public water supply system having a traditional water heater. This device compensates for increased water/gas pressures that can result due to the large volume of heated water being stored inside the water heater. Conditions were considered normal but due to the device being wrapped in a thermal blanket, a full evaluation was not able to be completed.

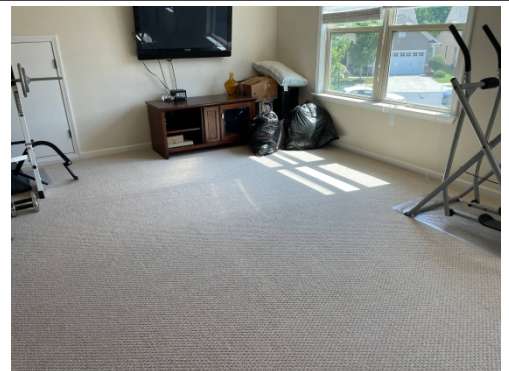
43. Observation/Information: Minor 2nd Floor Noise Present - Floor coverings prevented full inspection of some floor surfaces. Where visible, floor condition is serviceable and typical for the age of the home. Observed some areas in the 2nd floor system where the subfloor is loosely secured to the floor trusses/floor joist. This results in some minor floor deflection and/or squeaking in the floor when walked on. This is a common occurrence in many floor systems and can be repaired by pulling up the floor coverings and adding additional fasteners (preferable screws) in the areas of the loose subfloor.

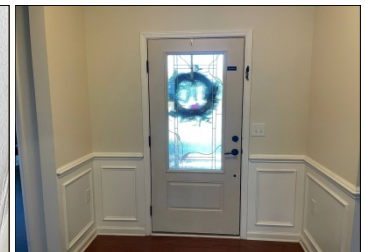
Front door hinge screws missing

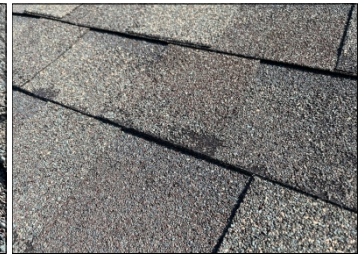
Normal wear to the shingles was observed. If concerns are present have a roofing contractor evaluate the roof and repair/replace components as needed.
