Advantage
Inspection

CHIMNEY/FLUE SCOPE REPORT

Sample Report

Date/Time: 6.19.2023 9:00 AM
Weather: 70 Degrees Cloudy

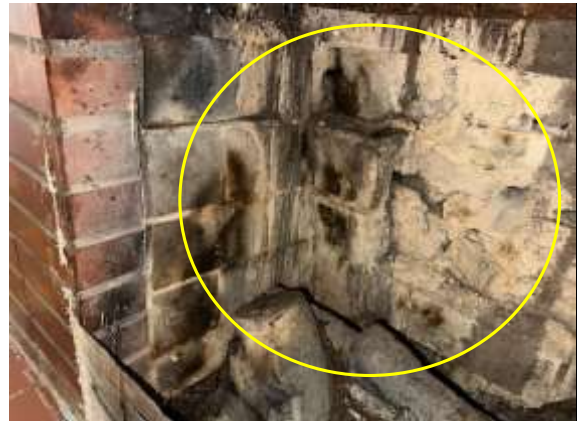
Firebox - Firebrick mortar deterioration present. This can allow heat to pass through the firebox wall and can result in loose bricks.	Photo 4
	INFO

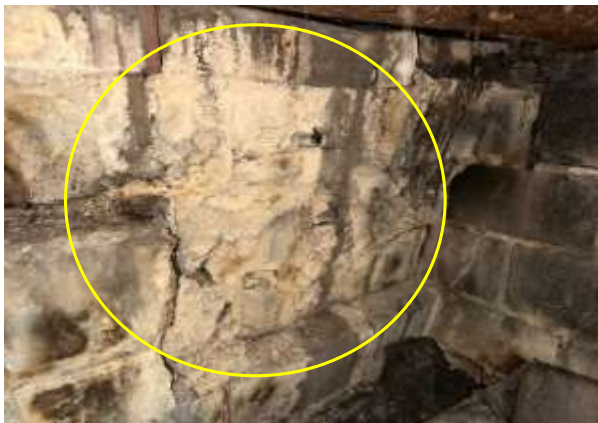
Firebox - Firebrick mortar deterioration present. This can allow heat to pass through the firebox wall and can result in loose bricks.	Photo 5
	LOG

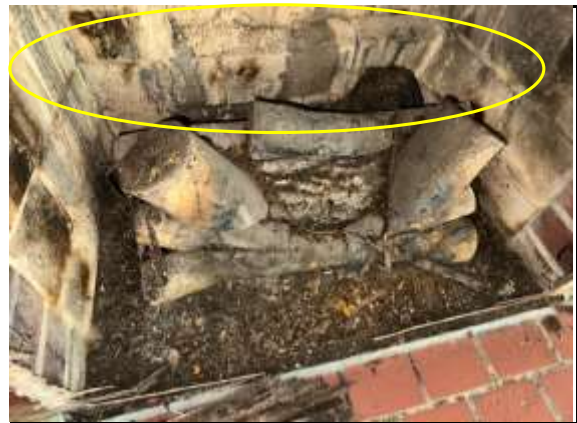
Firebox - Firebrick mortar deterioration present. This can allow heat to pass through the firebox wall and can result in loose bricks.	Photo 6
	LOG

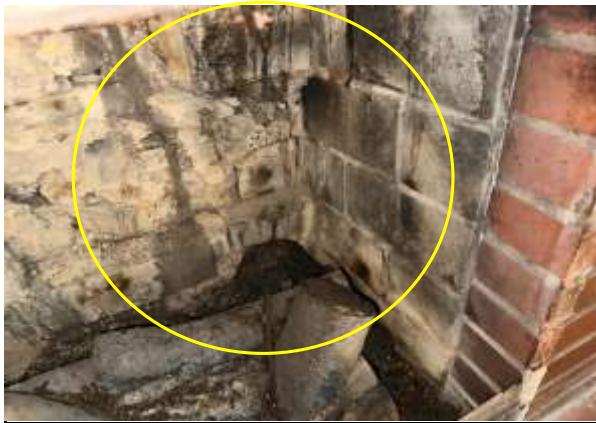
Photo 7

Firebox - Firebrick mortar deterioration present. This can allow heat to pass through the firebox wall and can result in loose bricks.

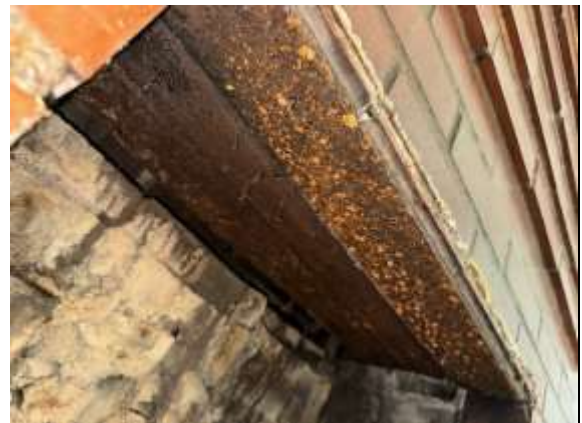
Photo 8

The fireplace lintel is rusted and shows some signs of deterioration. Service/repair is needed to prevent further deterioration.

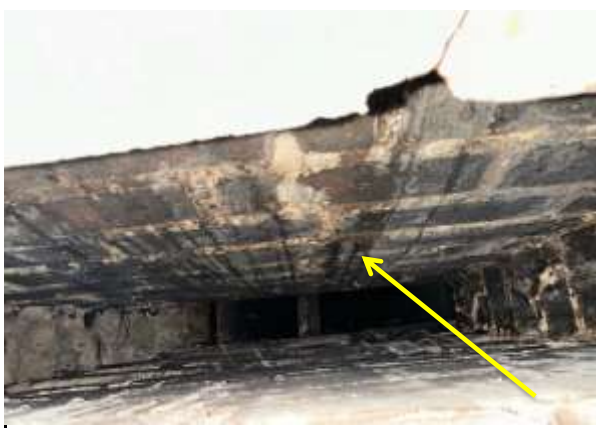
Photo 9

Smoke Chamber - Signs of moisture running through the area.

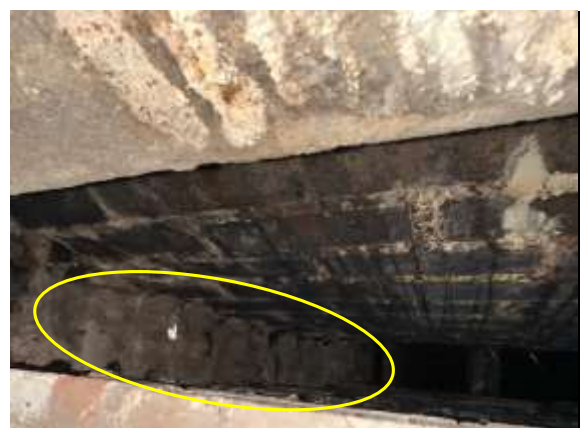
Photo 10

Smoke Chamber - Mortar deterioration is present in the smoke chamber. This can allow heat to pass through the wall and can result in loose bricks.

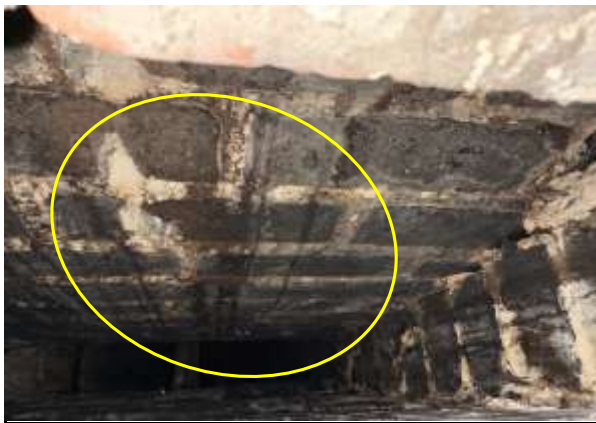
Photo 11

Smoke Chamber - Signs of moisture running through the area.

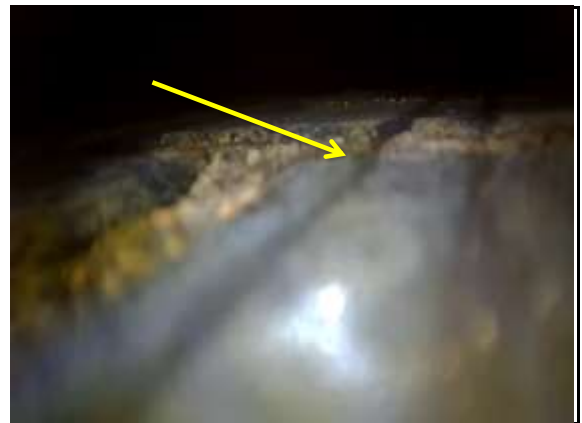
Photo 12

Smoke Chamber - Signs of moisture running through the area.

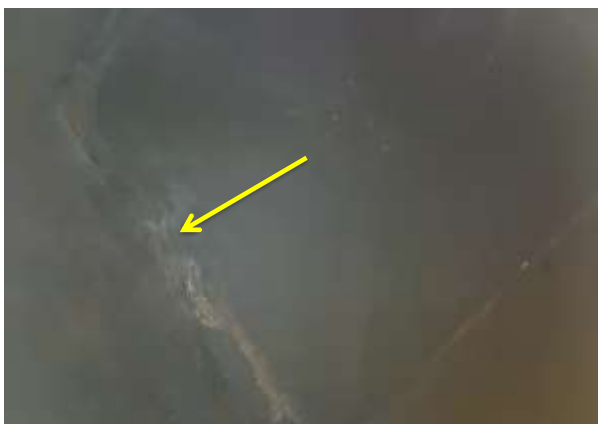
Flue - Soot Deposits - There is an accumulation of soot/debris in the flue. Soot deposits increase the risk of flue fire. Recommend regular cleaning.	Photo 15
	INFO

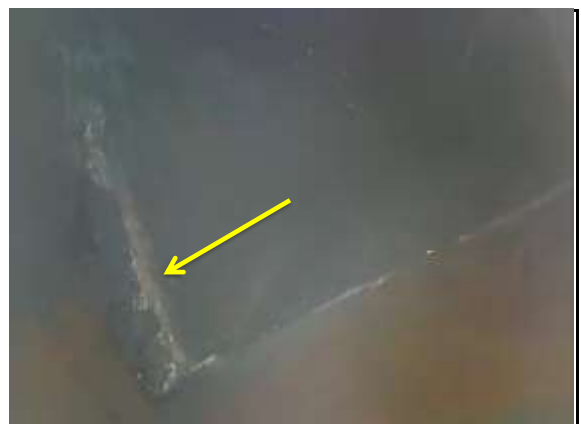
Flue - Soot Deposits - There is an accumulation of soot/debris in the flue. Soot deposits increase the risk of flue fire. Recommend regular cleaning.	Photo 16
	INFO

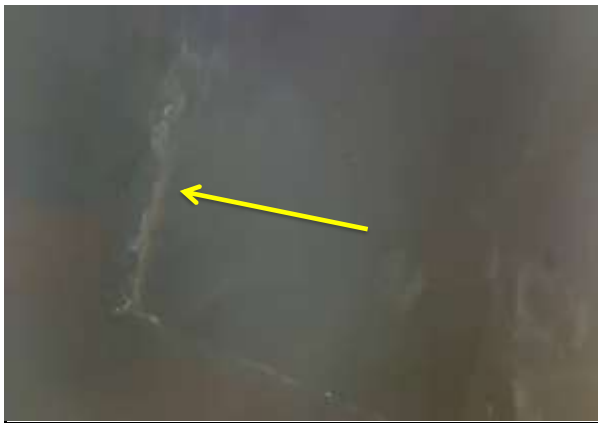
Flue - Soot Deposits - There is an accumulation of soot/debris in the flue. Soot deposits increase the risk of flue fire. Recommend regular cleaning.	Photo 17
	INFO

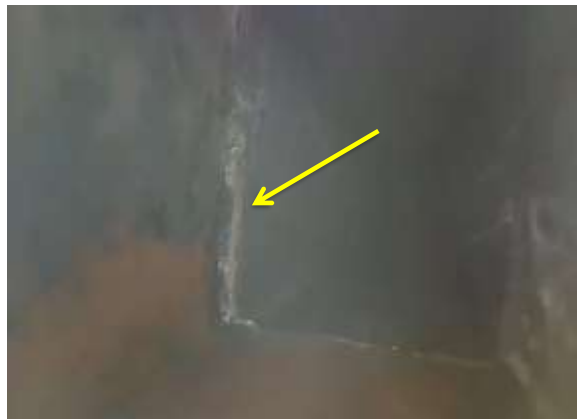
Flue - Soot Deposits - There is an accumulation of soot/debris in the flue. Soot deposits increase the risk of flue fire. Recommend regular cleaning.	Photo 24
	LOG

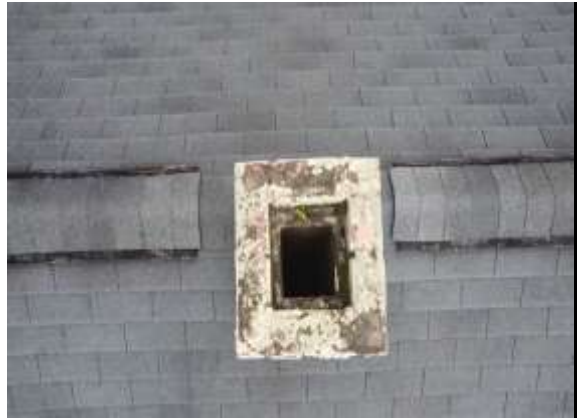
Old flue/chimney - There is a second chimney on the home that used to serve an old gas/oil fired furnace system or water heater. These flues commonly have openings into the crawlspace. The open cap can allow water/pests/debris into the	Photo 32
	LOG

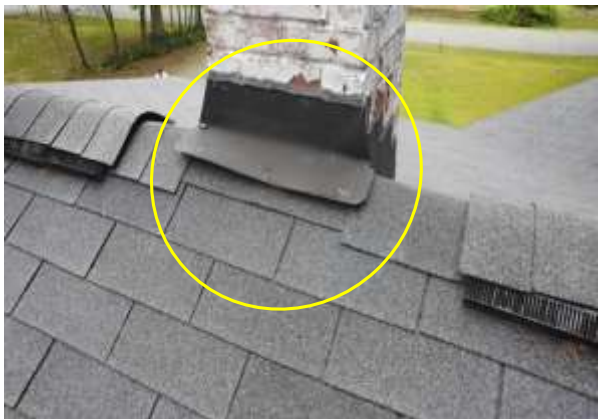
Chimney Penetration Flashing - Deteriorated/Lifting up. This can result in moisture penetration and damage.	Photo 35
	LOG
