Inspection Report

Report - Property/Home
Inspection

06.26.24

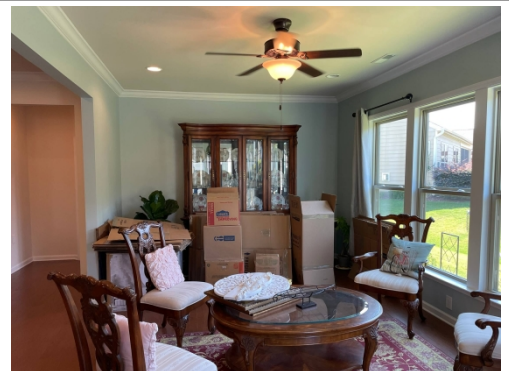
42. Limited Evaluation: Observed personal items stored throughout the house. This limits access to various areas, and will prevent inspection of windows and outlets that are covered by personal items. Efforts were made to observe all areas, but the evaluation may have been limited.

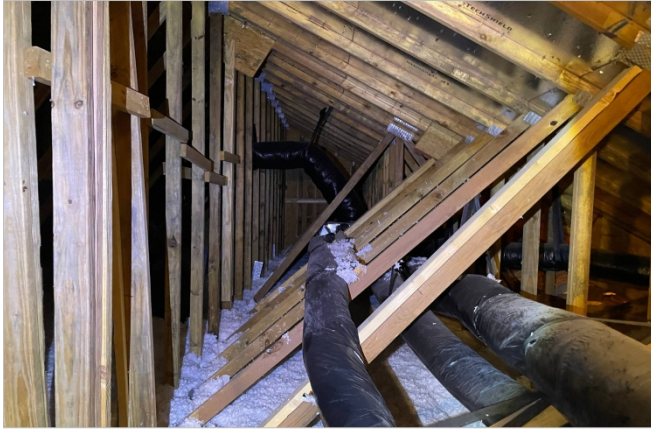
Roof structure observed in the attic, some areas of the attic were not fully accessible/visible due to limited attic flooring, ductwork and low clearances.

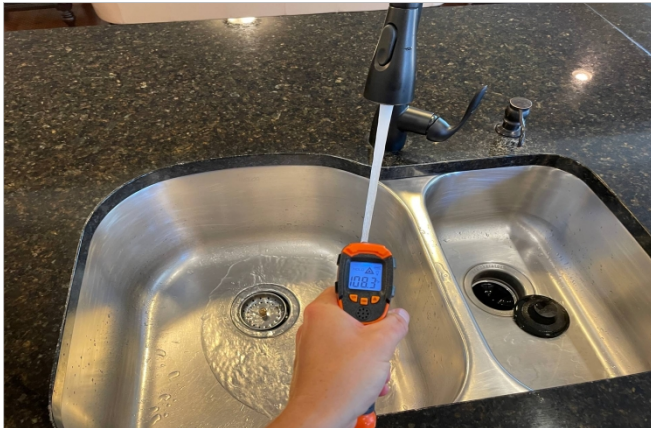
Water pressure, functional flow, drainage and hot water temperature readings observed.

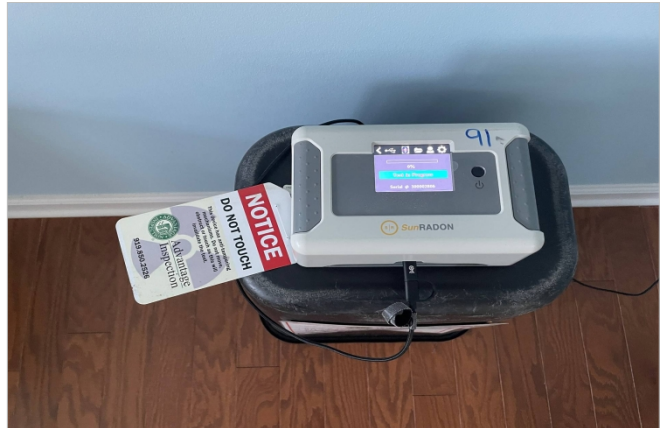
Radon monitor set in the front right bedroom.
48 hour test.

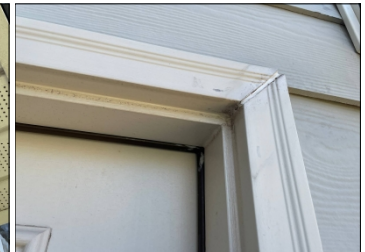
Needs Repair: Exterior Trim - Deteriorated Sealant -
 Unions of doors/window frames/exterior trim to the exterior wall cladding have areas of sealant adhesion failure present. Caulked joints that have cracked and/or separated need to be sealed in order to prevent any possibility of water intruding into the walls where damage can occur. Have a professional contractor properly prepare/reseal all areas where joints have been compromised.

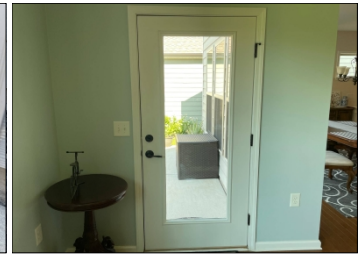
Needs Repair: Rear Door - Moisture Damage to Rear Door Trim -

The rear exterior door lower side wood jambs have wood deterioration present. Suggest adding a rain diverter along the roof edge to reduce water from running off the roof at the door trim area. Long term exposure to moisture can result in damage to the wood components of this door system and repairs/replacement are necessary. Have a professional contractor make all necessary repairs for long term serviceability.

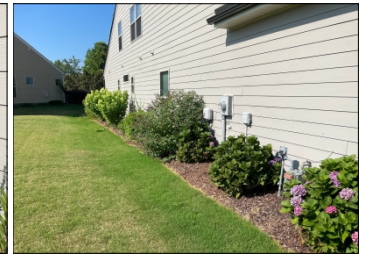
Observed vines/shrub limbs that are in contact with the house. Branches in contact with the house can cause damage to the shingled roof covering and water shedding off the trees can divert water toward the house. The canopy under large trees will hold higher moisture levels in them that will over time cause wood to deteriorate. Maintain large vegetation away from the house in order to prevent damage to the house and reduce higher moisture levels that can cause rot on wood surfaces.

>>> Note: Limbs over the fireplace chimney can cause poor drafting/back drafting in the fireplace.

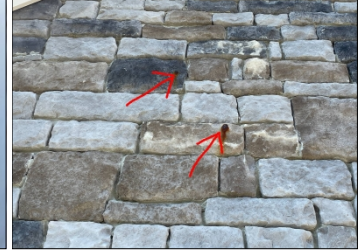
Needs Repair: Exterior Wall Cladding - Openings in Stone Veneer - Observed some openings in the stone veneer on the front elevation of the home. (See Photo) A veneer does not support the weight of any structure, but does support the weight of the stone. Openings in the mortar joints in the veneer can cause stones to fall from the wall as a result. Additionally, openings in these joints between the stone can allow water to intrude into openings and during extremely cold weather, freezing conditions will expand water and cause stone to crack or dislodge. Have a professional masonry contractor seal any open joints in the veneer exterior of the home.

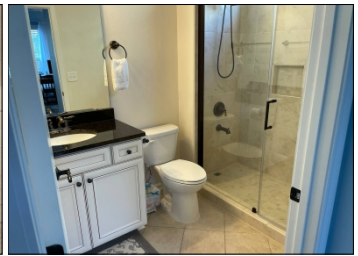
Needs Repair: Front Right Bedroom Bathroom - Shower Tile/Grout - The shower tile has evidence of cracking/separation present between the tiles/grout/sealant. (See Photo) Water that is able to intrude under the tile and can, over time, deteriorate the wall or floor structure under/behind the tile. Recommend having a professional tile installation contractor provide further evaluation and at a minimum, properly repair the deteriorated grout joints, so that the possibility of water penetration is prevented.

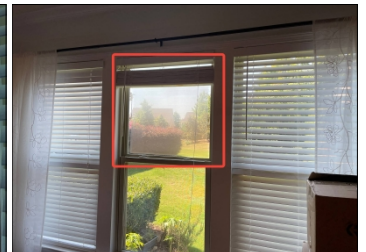
Needs Repair: Windows - Window Glass Unit Seal Failure -

Glass unit window insulation seals were observed to be compromised in a few locations throughout the home. - [Dining area bottom sash(1) & primary bedroom top sash(1)] Compromised glass seals may not necessarily be limited to just the glass units noted. Signs of compromised glass seals can be masked by weather conditions, lighting, and cleanliness of glass at the time of the inspection. Have a professional window pane replacement company evaluate all of the glass units in the home and make the necessary repairs/replacement to restore the insulation integrity of any units determined to have bad seals.
